**Hastings Borough Council**  
**Undercliff West of St Leonards Parish Church**  
Geotechnical Slope Inspection Report  
March 2021

## **Undercliff West of St Leonards Parish Church**

### Geotechnical Slope Inspection Report

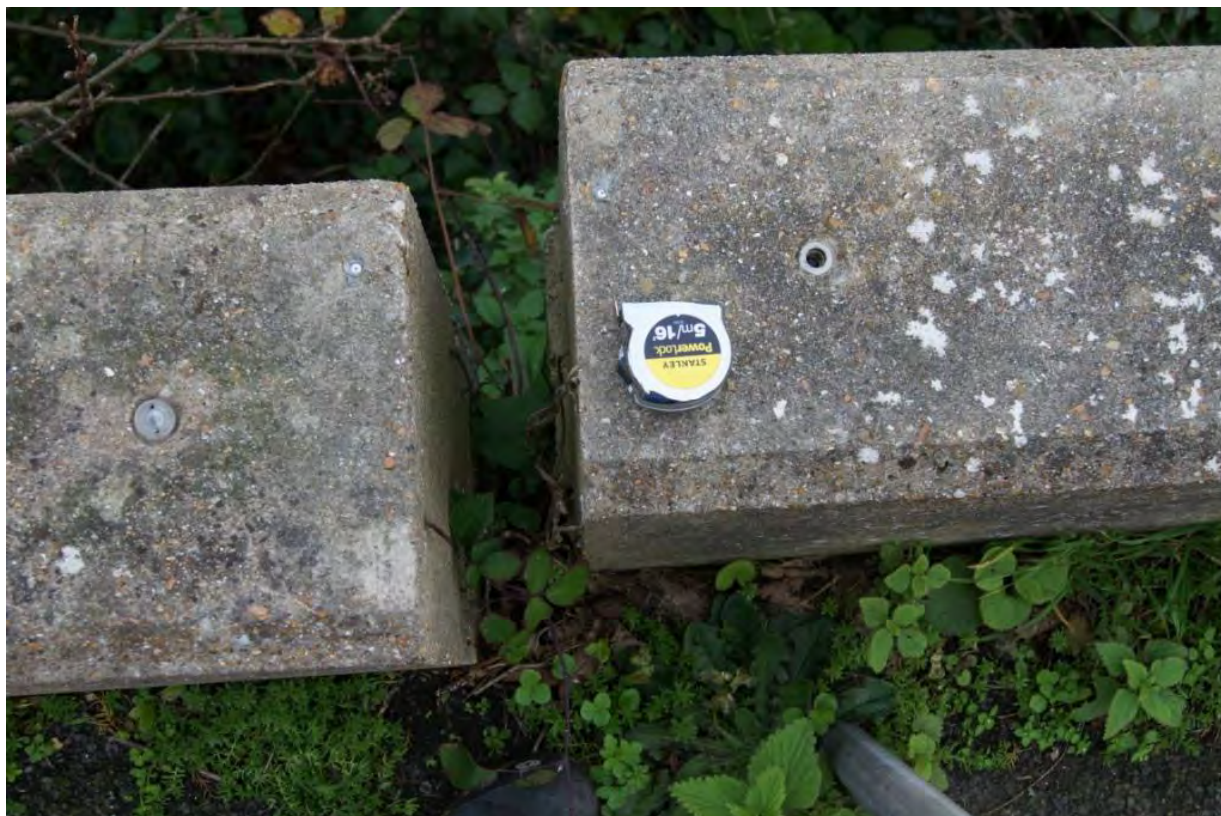
Wall A is located on the south and eastern side of the footpath towards the top of the slopes. This wall retains the footpath and the land to the north and west. Construction joints between the individual sections of wall appeared to be displaced both laterally and longitudinally.

The displacement of the first joint downslope from West Hill Road was measured to have an offset of 30mm (with the northerly section offset to the east). During the 2016 inspection this joint did not show any signs of movement. Moving down the path multiple joint displacements were identified and these were between 10mm and 180mm with the largest offsets along the section of wall facing south (Photo 1). The south facing section of Wall A was typically offset to the south and the corner segment of the wall appeared to be displaced in a south-easterly direction.

**Photo 1. Wall A. Joint opening and rotating with a displacement of 100mm to the south.**

- Wall A is of marginal stability and it is considered that currently the wall poses a low to moderate risk to users of the path. However, it is likely that the wall will continue to deteriorate as the slope continues to move below it and the consequential risk will be greater as it becomes undermined.

- Do not reopen the footpath until the south east corner of Wall B is replaced. Any reopening should be agreed with HBC and East Sussex Highways and inspected by a structural engineer..
- Remove vegetation from Wall E to allow an inspection of the retaining walls that support West Hill Road above the site.
- Remove vegetation from the top section of the slope between Wall A and Wall D to allow an inspection of the foundations of Wall A as they are becoming exposed by movement of the soil below.

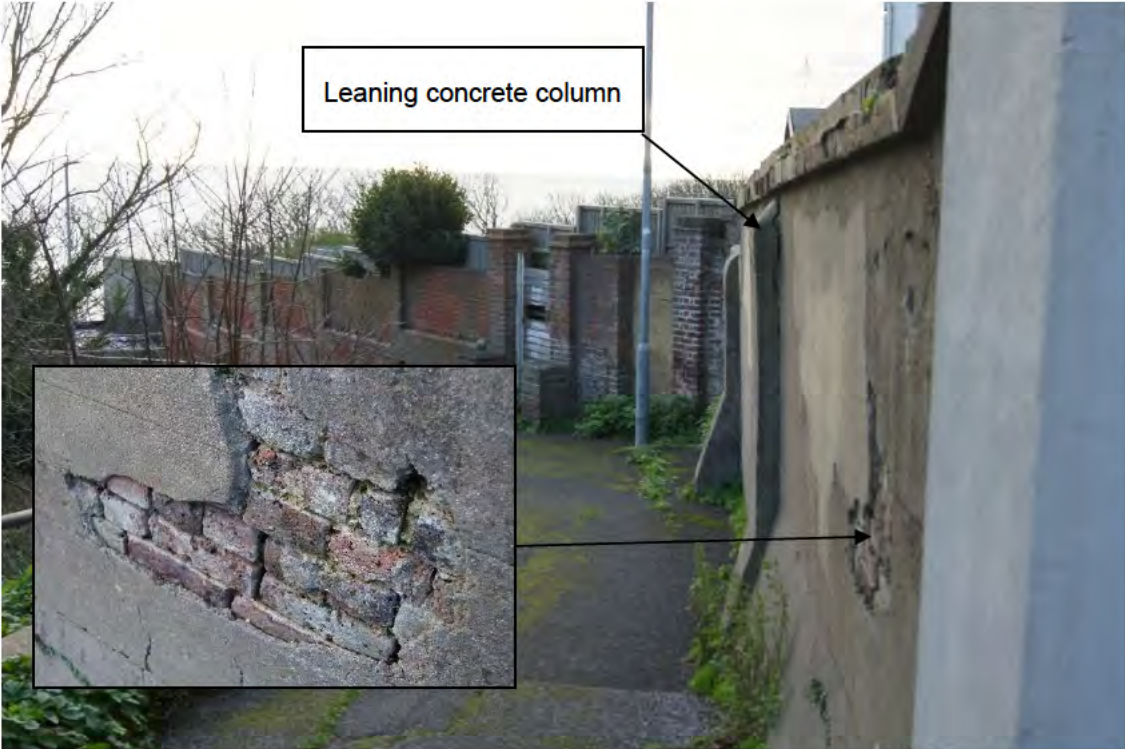
On the first section of Wall B (downslope from West Hill Road), which runs NE-SW, the wall appears to be constructed of bricks and faced with concrete which is supported by concrete columns (Photo 2). There are many visible cracks and the concrete facing appears to have broken off in some areas leaving exposed brickwork. The wall is also leaning outwards with one of the columns measuring 5° from vertical.

**Photo 2. Upper section of Wall B showing wall cracking and leaning outwards.**

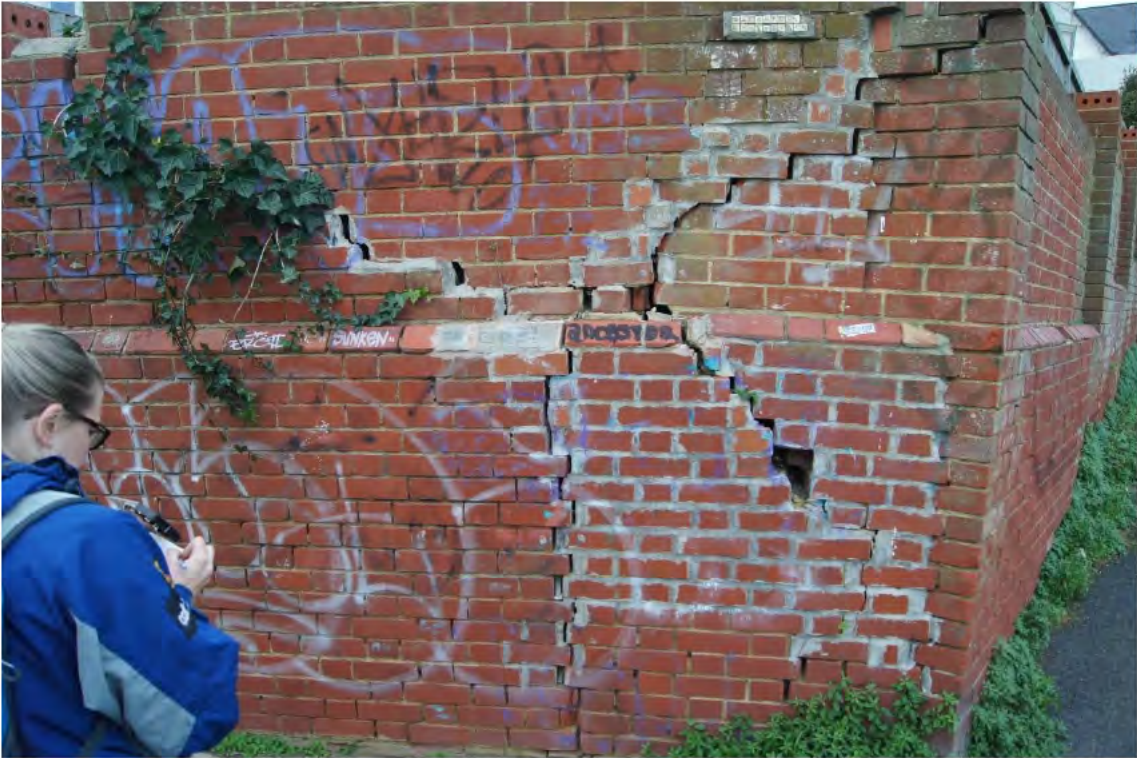
The southern face of Wall B is a brick wall which is leaning outwards at an angle of approximately 10° and appears to be buckling in the central section. The wall has an extensive network of cracks with some areas of brick being horizontally offset by at least 60mm (Photo 3). The displacement of the bricks at this location has extended to the far east corner of the wall since the inspection by Coffey in 2016 and the wall has deteriorated. The section of Wall B showed lateral displacement to the west and south plus rotation of the middle and upper parts of the wall to the south east.

**Photo 3. Southern face of Wall B showing extensive cracking and significant horizontal displacement of bricks.**

- The ground movement could lead to failure of the walls, with the south east corner of Wall B appearing to be in the worst condition at the time of the inspection. It is considered that failure of Wall B poses a high risk to users of the path. It is understood that the footpath has been closed due to the risk posed by this wall.

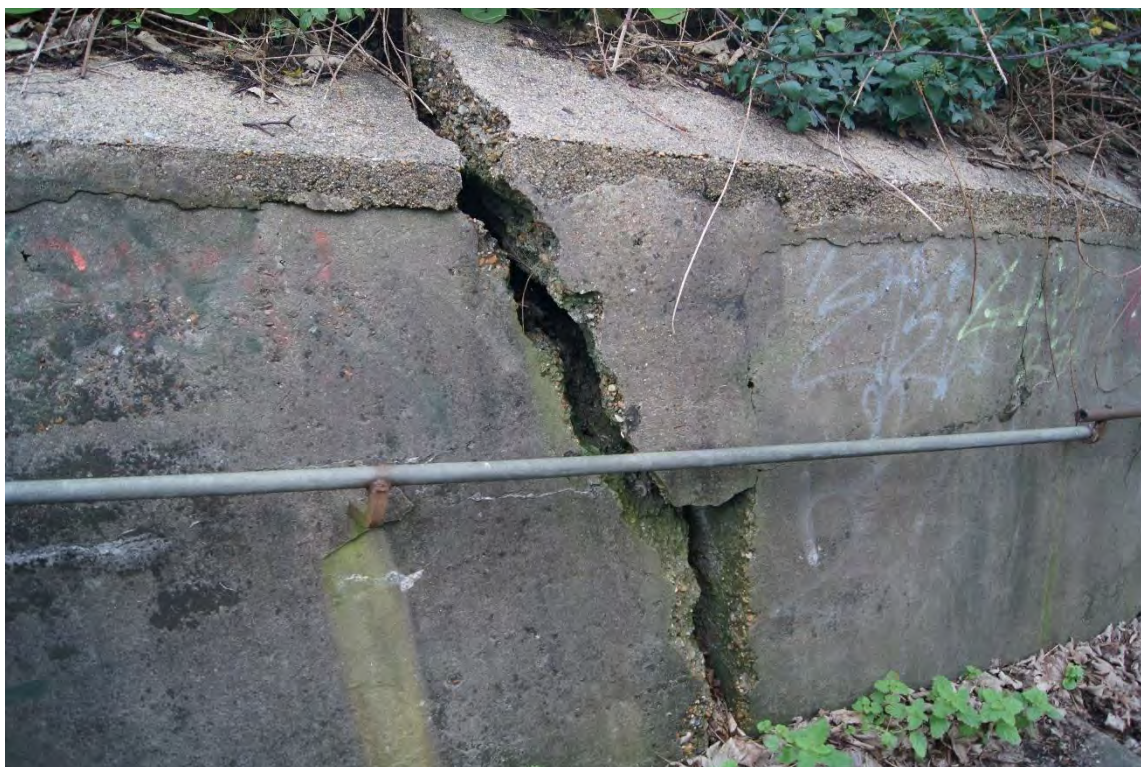
The wall was observed to be leaning towards the south at a typical angle of 10° from vertical. There were several significant cracks observed which were up to 300mm wide. In some areas the handrail has become detached due to the movements exhibited by the wall (Photo 4). This area has not deteriorated significantly since the 2016 inspection.

**Photo 4. Large crack on Wall C. Broken railing can be seen on the right side of the photograph.**

- Wall C is of marginal stability and it is considered that currently the wall poses a low to moderate risk to users of the path. However, it is likely that the wall will continue to deteriorate and the consequential risk will be greater.

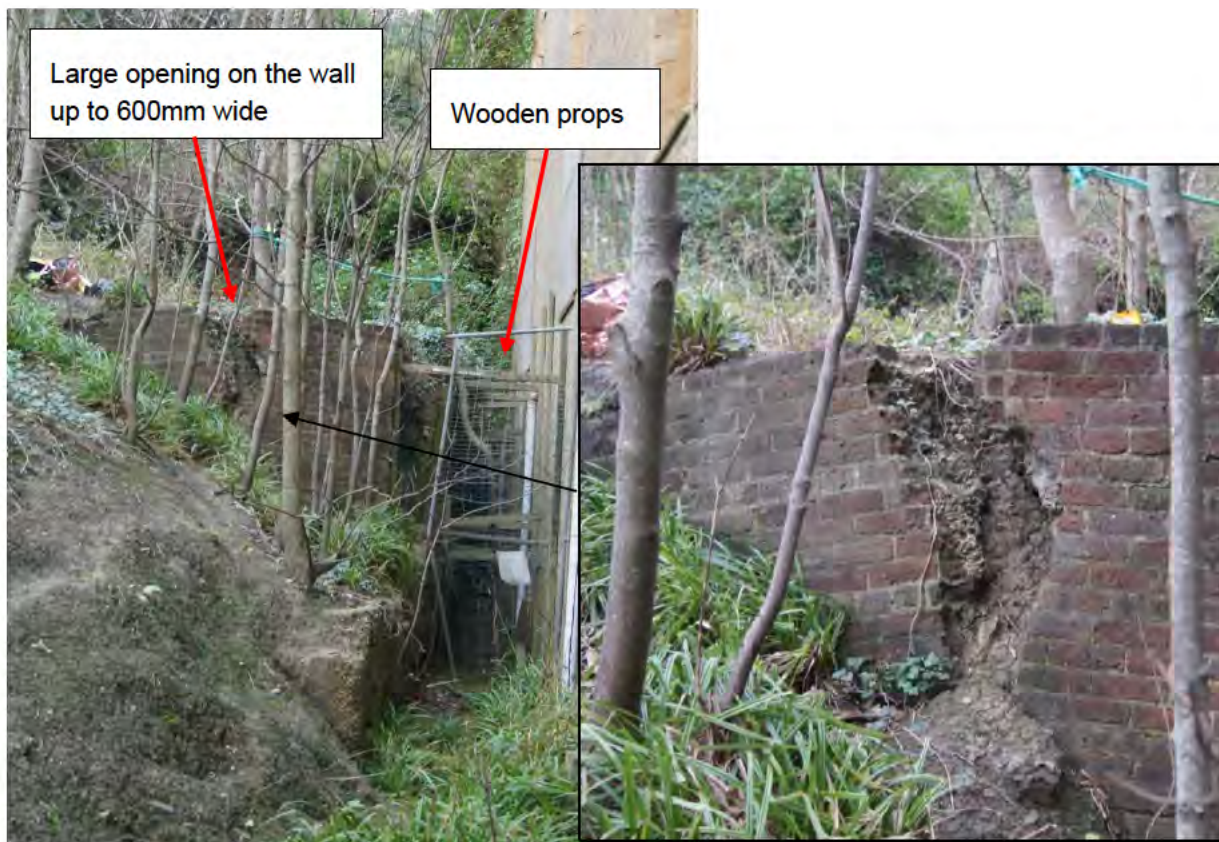
Wall D is located adjacent to the west side of St Leonards Parish Church. The wall is leaning towards the church (to the east) and has broken up into 2 sections with a large opening in between up to 600mm wide (Photo 5). The wall is currently supported by timber walings and props off the west side of the church wall. The Clayton 1998 report postulates that inside the church there was a complimentary system of walings and shoring which occupied a considerable part of the floor area on the western side of the nave, The method of transferring load through the cavity of the west exterior wall of the church was not apparent.

No significant deterioration of this wall has occurred since the 2016 inspection.

**Photo 5. Wall D leaning towards the church.**

- Wall D and the slope above are marginally stable and are being supported by a system of braces onto and through the church wall. The long-term effectiveness of this system and its influence on the structure of the church needs to be investigated and assessed. It is considered that the wall currently poses a low risk to users of the path and a high risk to the church and persons accessing the slope in this area (noted that homeless appeared to be using the top of the wall as a resting place).

- Prevent access to the slopes surrounding Wall D and around the church, where it was observed that people were using it as an area to rest.
- Undertake a drainage inspection of the site and the area to the north (West Hill Road and Archery Road). Clear and maintain all drainage to ensure it is functioning adequately. Given the significant role water plays in landslide activity this is considered of high importance.

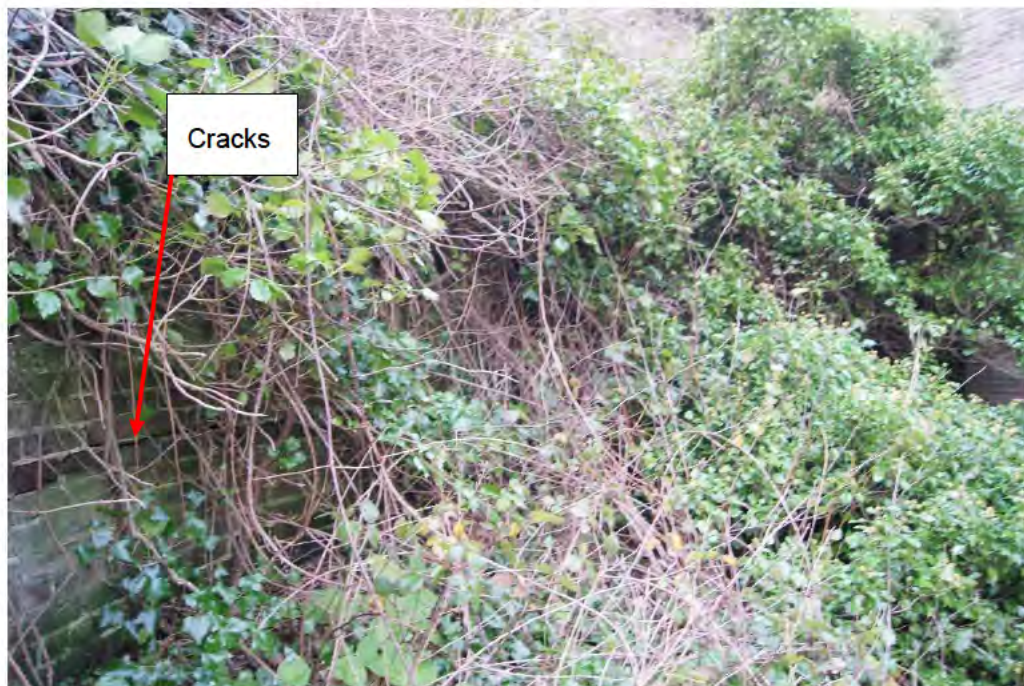
To the north west of the church some sections of a retaining wall were visible, and this may have formed the western extent of Wall E. This wall was showing signs of distress (Photo 6).

**Photo 6. Wall E exhibiting some cracking.**

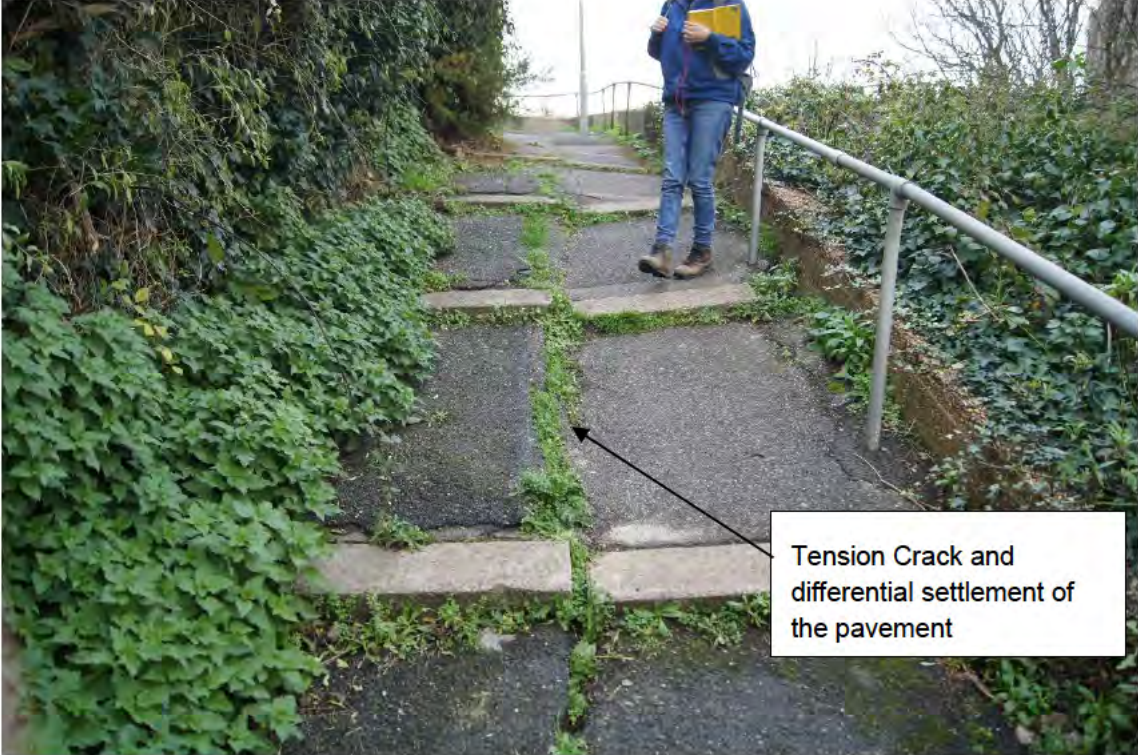
The footpath in between Wall A and Wall B is showing significant signs of distress, particularly on the southern section (upslope of Wall C). Photo 7 shows what appears to be a tension crack running parallel to the slope.

The footpath was visibly showing signs of distress through the whole site. This was the most visible on the east to west orientated section between Wall A and B (Photo 7) and the north west to south east orientated section below Wall C (Photo 8) where tension cracks were visible through the paving. Between the 2016 and 2020 inspections, the condition of the footpath has deteriorated with the tension cracks and differential settlement of the paving becoming more distinct.

**Photo 7. Footpath located between Wall A and B orientated east to west.**

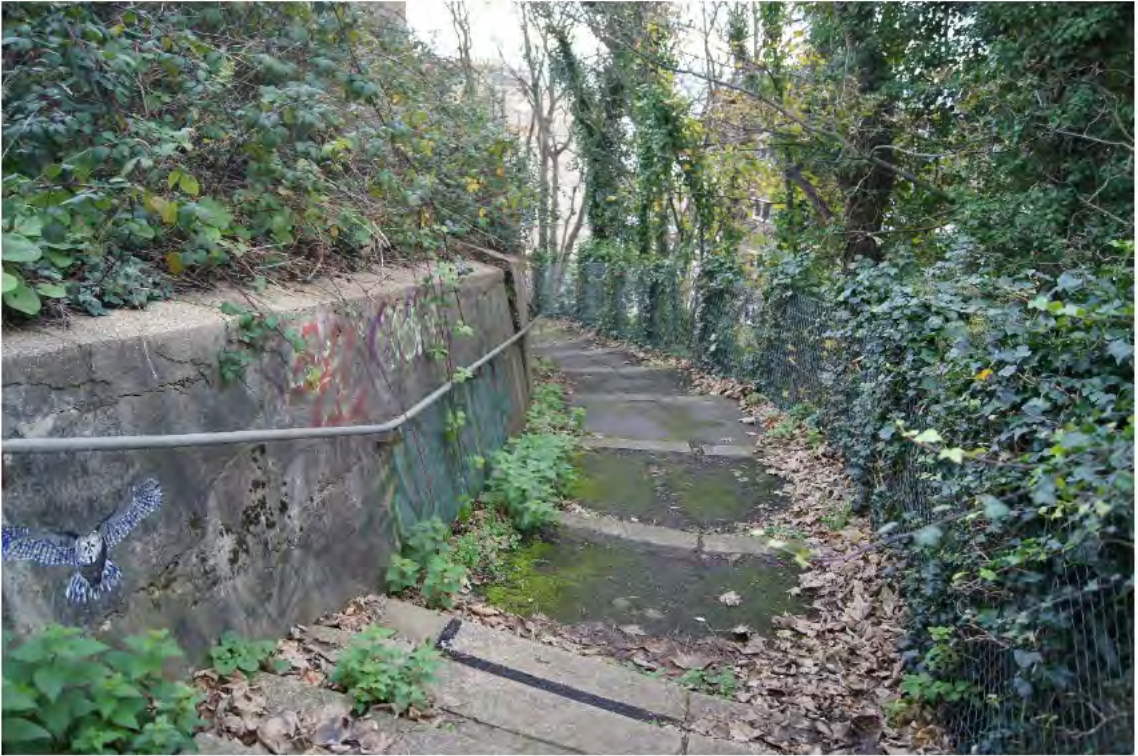
**Photo 8. Footpath adjacent to Wall C.**

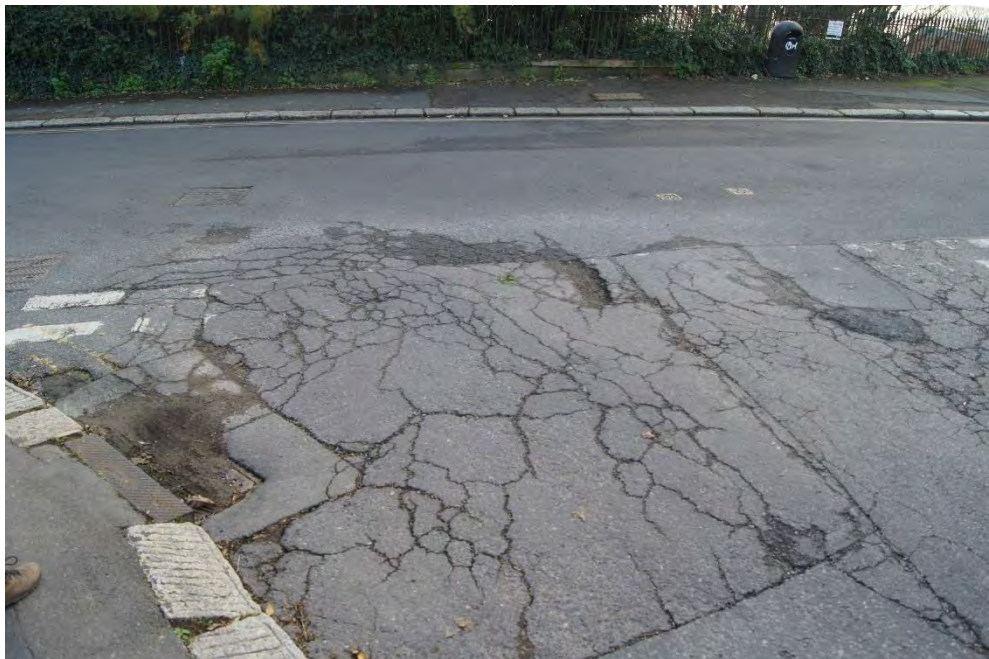
Numerous signs of instability were identified on West Hill Road which is situated above the site. These included multiple cracks in the road itself (Photo 9) and within the wall forming the West corner of the junction with Archery Road (Photo 10). The cracks in the road surface were not observed during the inspection in 2016 and the cracks in the walls appear to be more pronounced.

Photo 9 shows that the grid at the junction is silted up and indicates that the drainage above the site is not functioning adequately. It is recommended that a drainage survey in this area and through the site is undertaken with all drainage inspected and cleared out where it is observed to be functioning inadequately.

**Photo 9. Cracks and silted up drain visible in the road forming the junction between West Hill and Archery Road.**

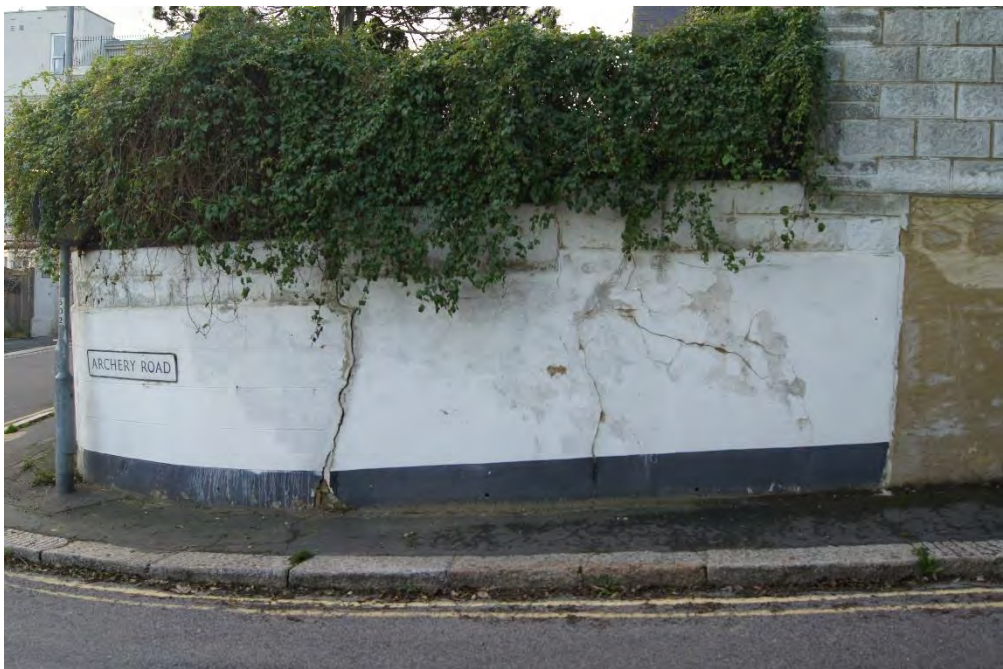
**Photo 10. Cracks visible in the wall forming the junction between West Hill and Archery Road.**
