| <b>Survey Unit</b> | <b>4cSU20 – Hastings</b> | |
| <b>SMP Policy</b> | <b>Hold the Line</b> | |

Hastings is a shingle beach with a sand foreshore and sections of exposed chalk platform. The unit extends 4.6 km between Cinque Ports Way and East Hill. There are a number of timber and rock groynes throughout the frontage, at varying intervals. Occasional beach management works are undertaken as required.

#### Survey outcome:

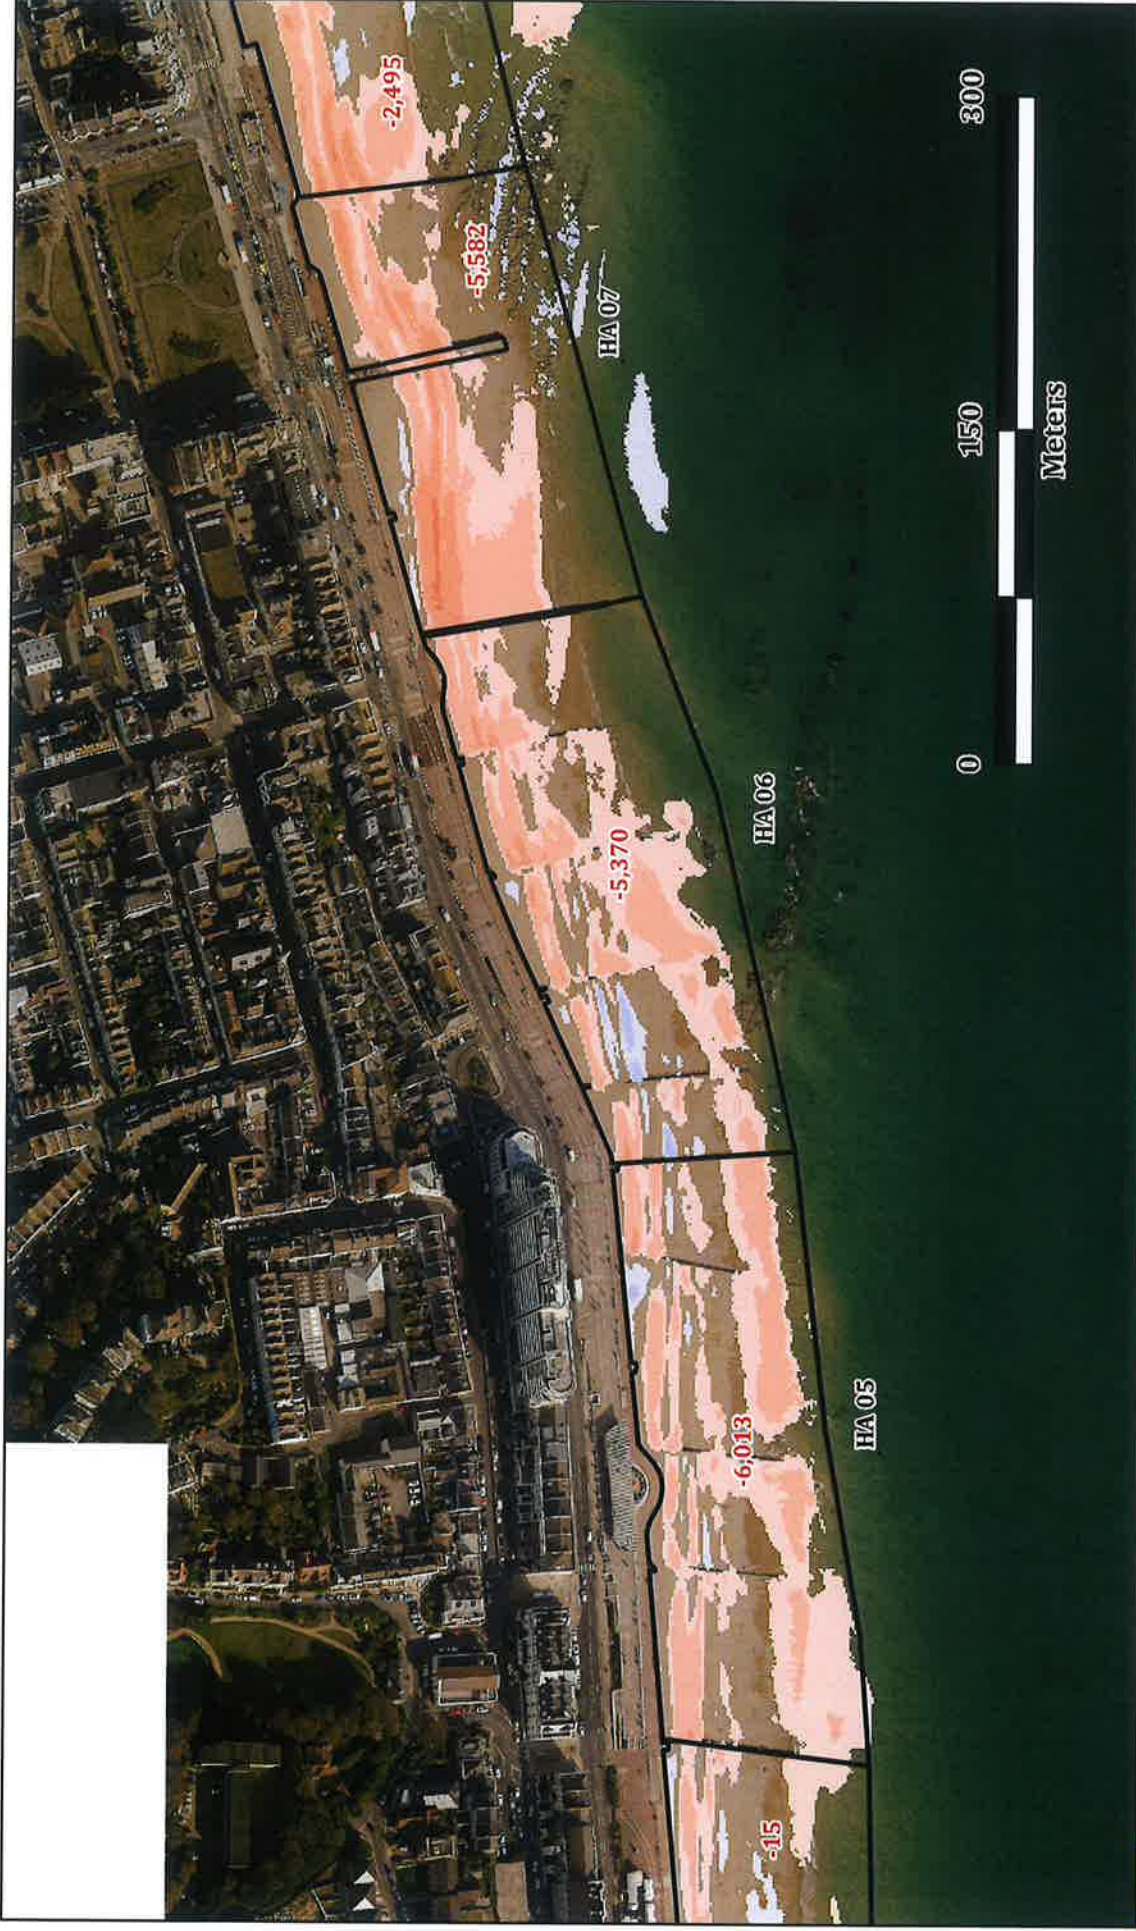
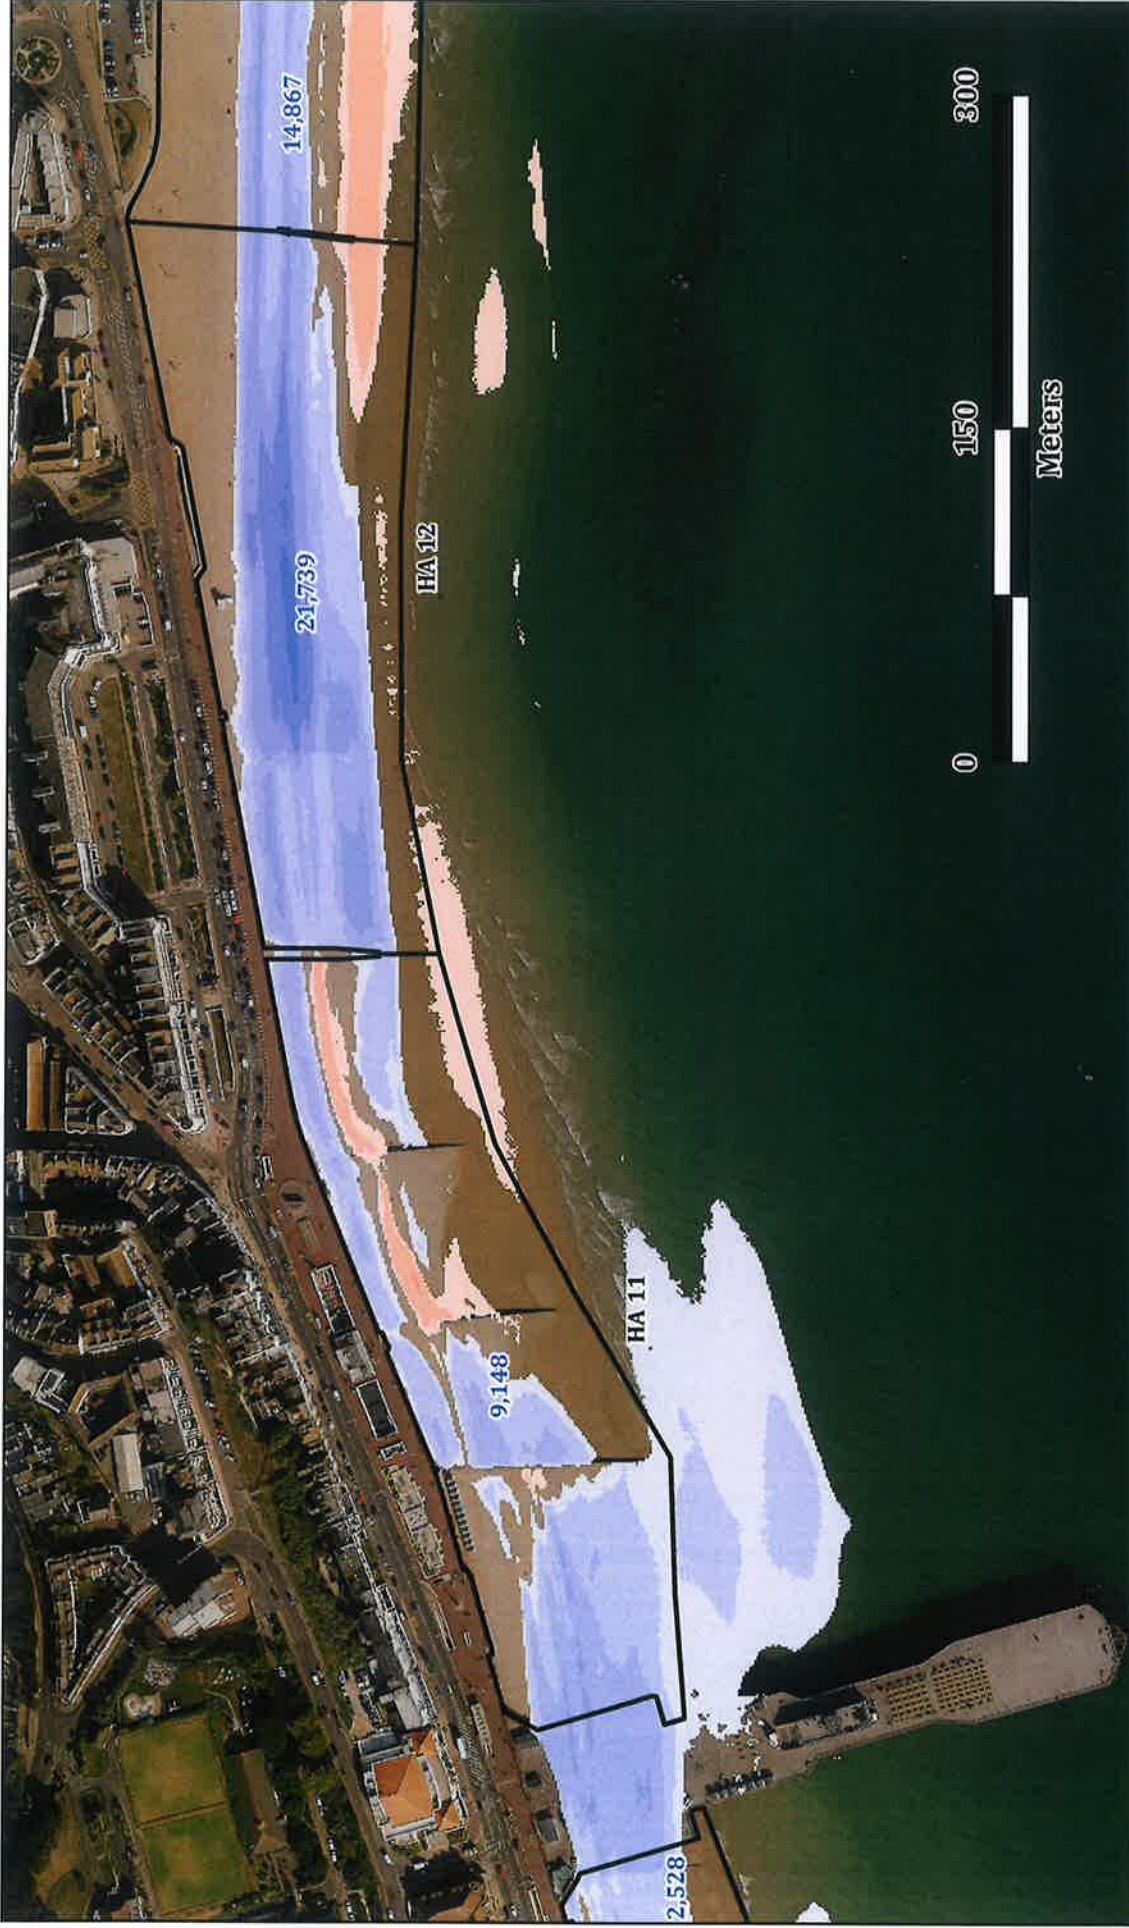
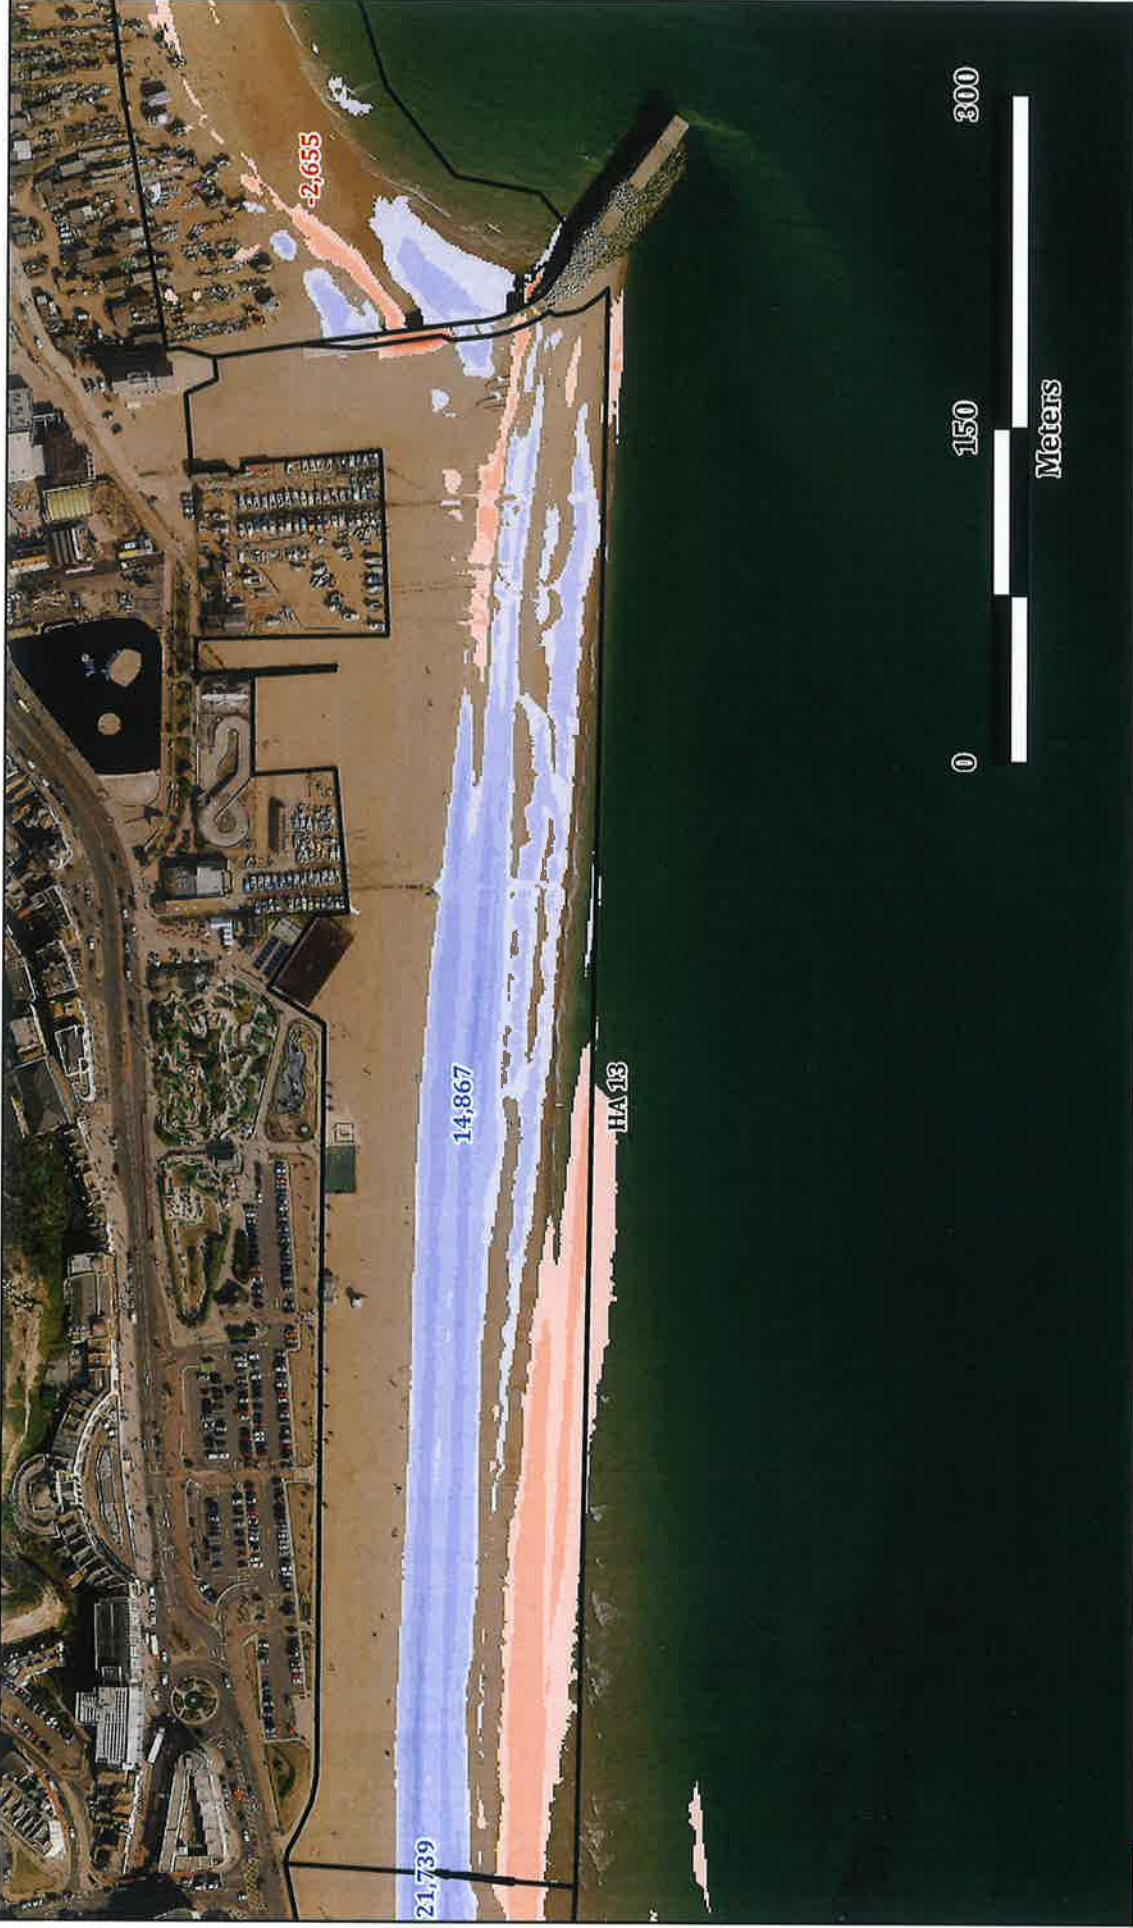
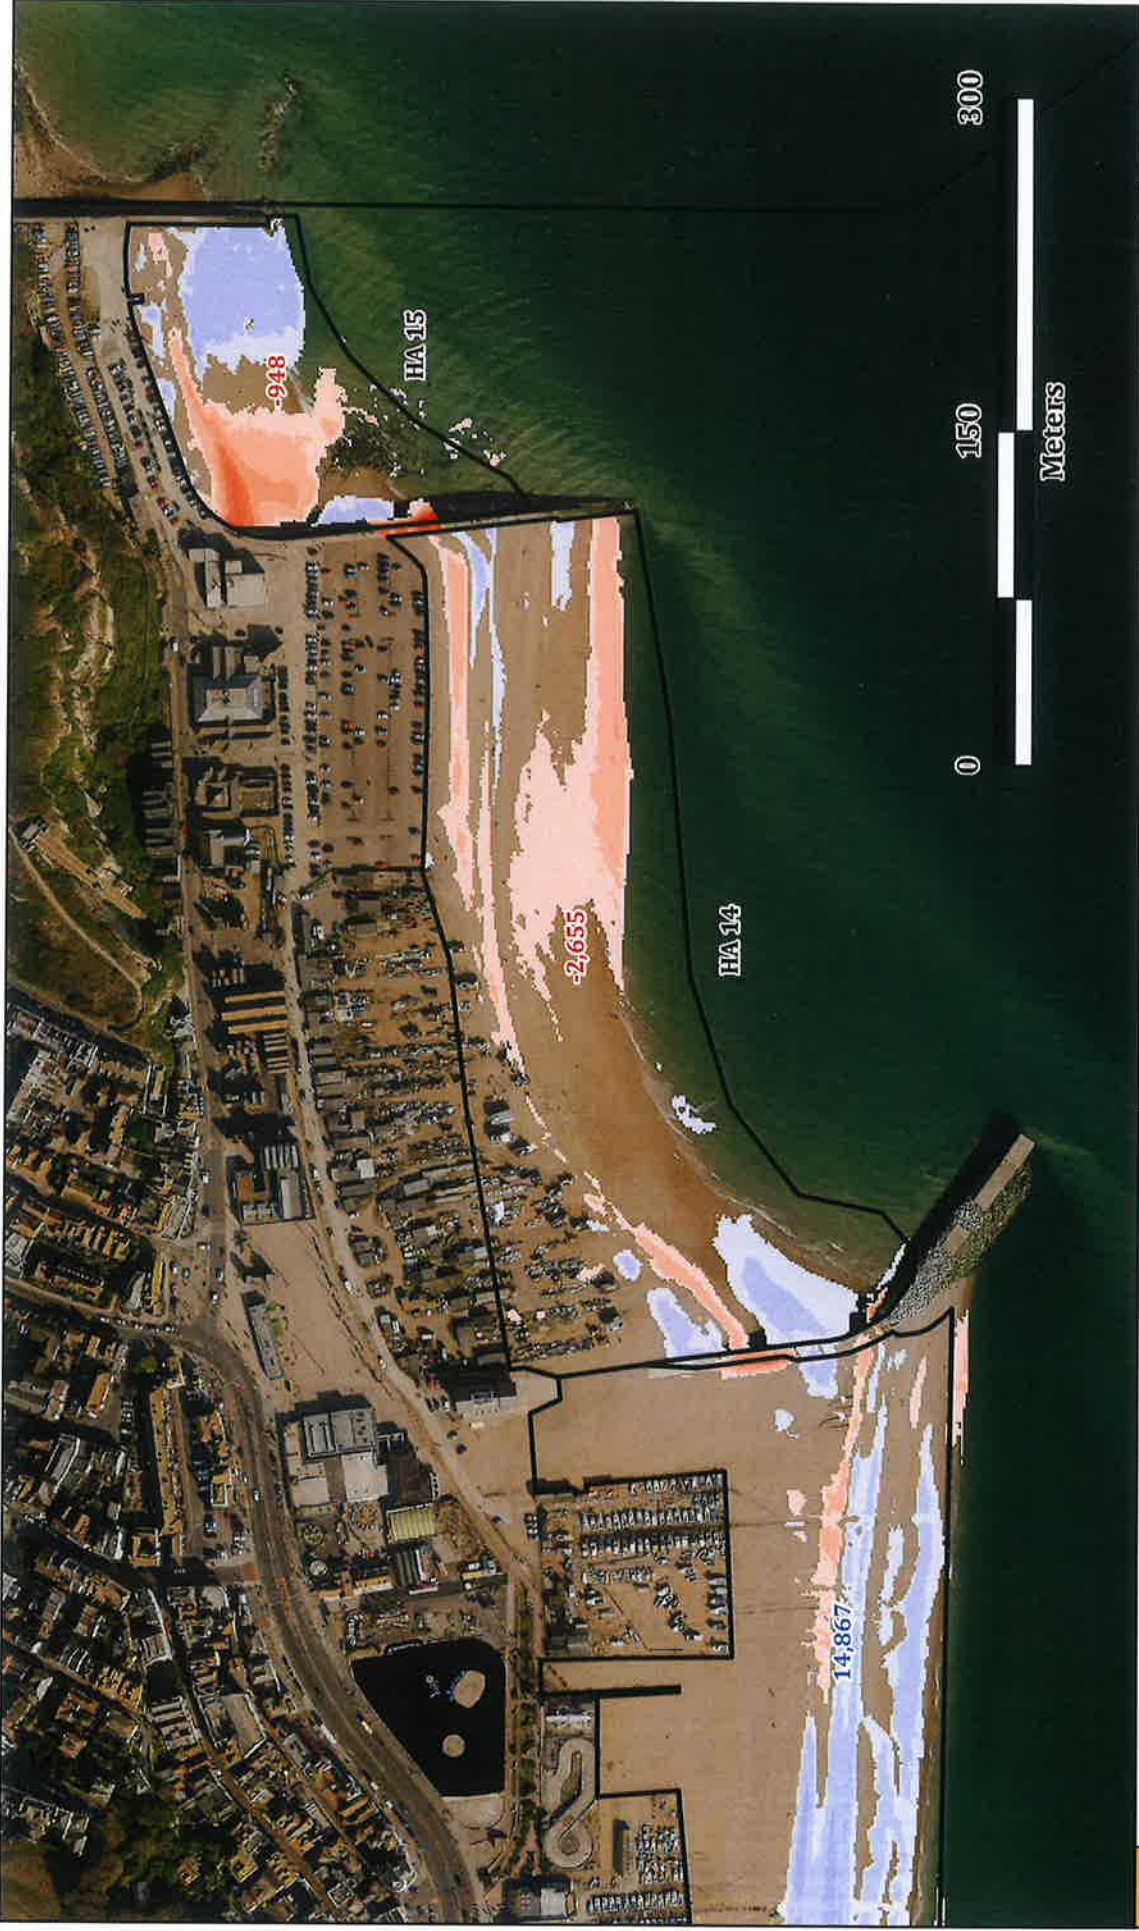
# South East Regional Coastal Monitoring Programme Difference Model 2021 - 2021

| Survey type | Survey dates | Comments |
|---|---|---|
| Spring to Spring | Topographic difference model and Profile Change | <p>09/06/2020<br/>13/04/2021</p> <p>Hastings beach has gained a total of 34,247m<sup>3</sup> between June 2020 and April 2022.</p> <p>The majority of this gain is recorded along the open beach to the east of the Pier with polygons HA11, 12 and 13 accumulating 45,754m<sup>3</sup>. To counteract this gain, the majority of the western side of the Pier lost material. Fisherman's beach and Rock-a-Nore lost 2,655m<sup>3</sup> and 948m<sup>3</sup> respectively.</p> <p>Beach recycling exported 4,900 from HA13 to HA11 in June 2021.</p> |

Recycling works were carried out in June 2021, whereby 4,904m<sup>3</sup> of material was extracted directly west of the harbour arm and deposited within the groyne bays to the east of the pier. For more information, refer to the recycling logs in Appendix C.

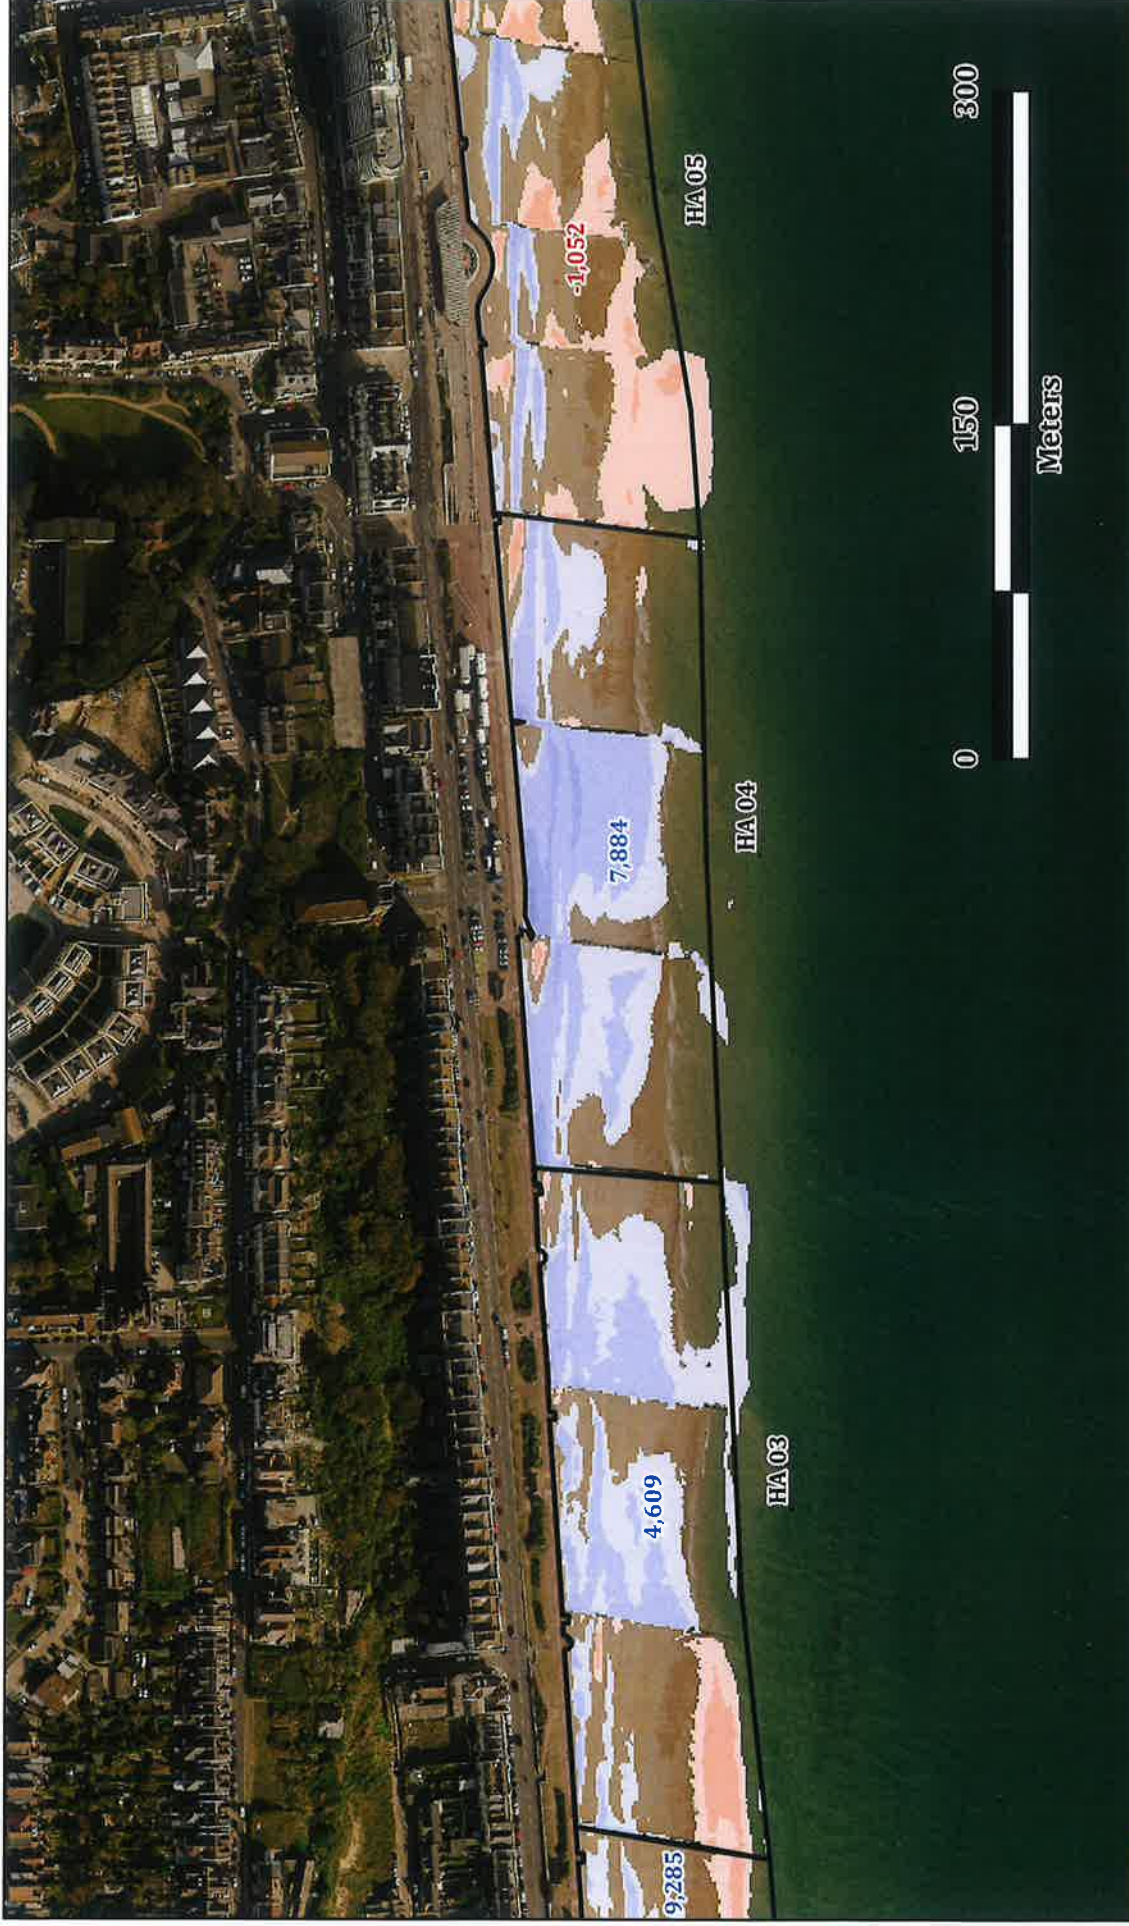
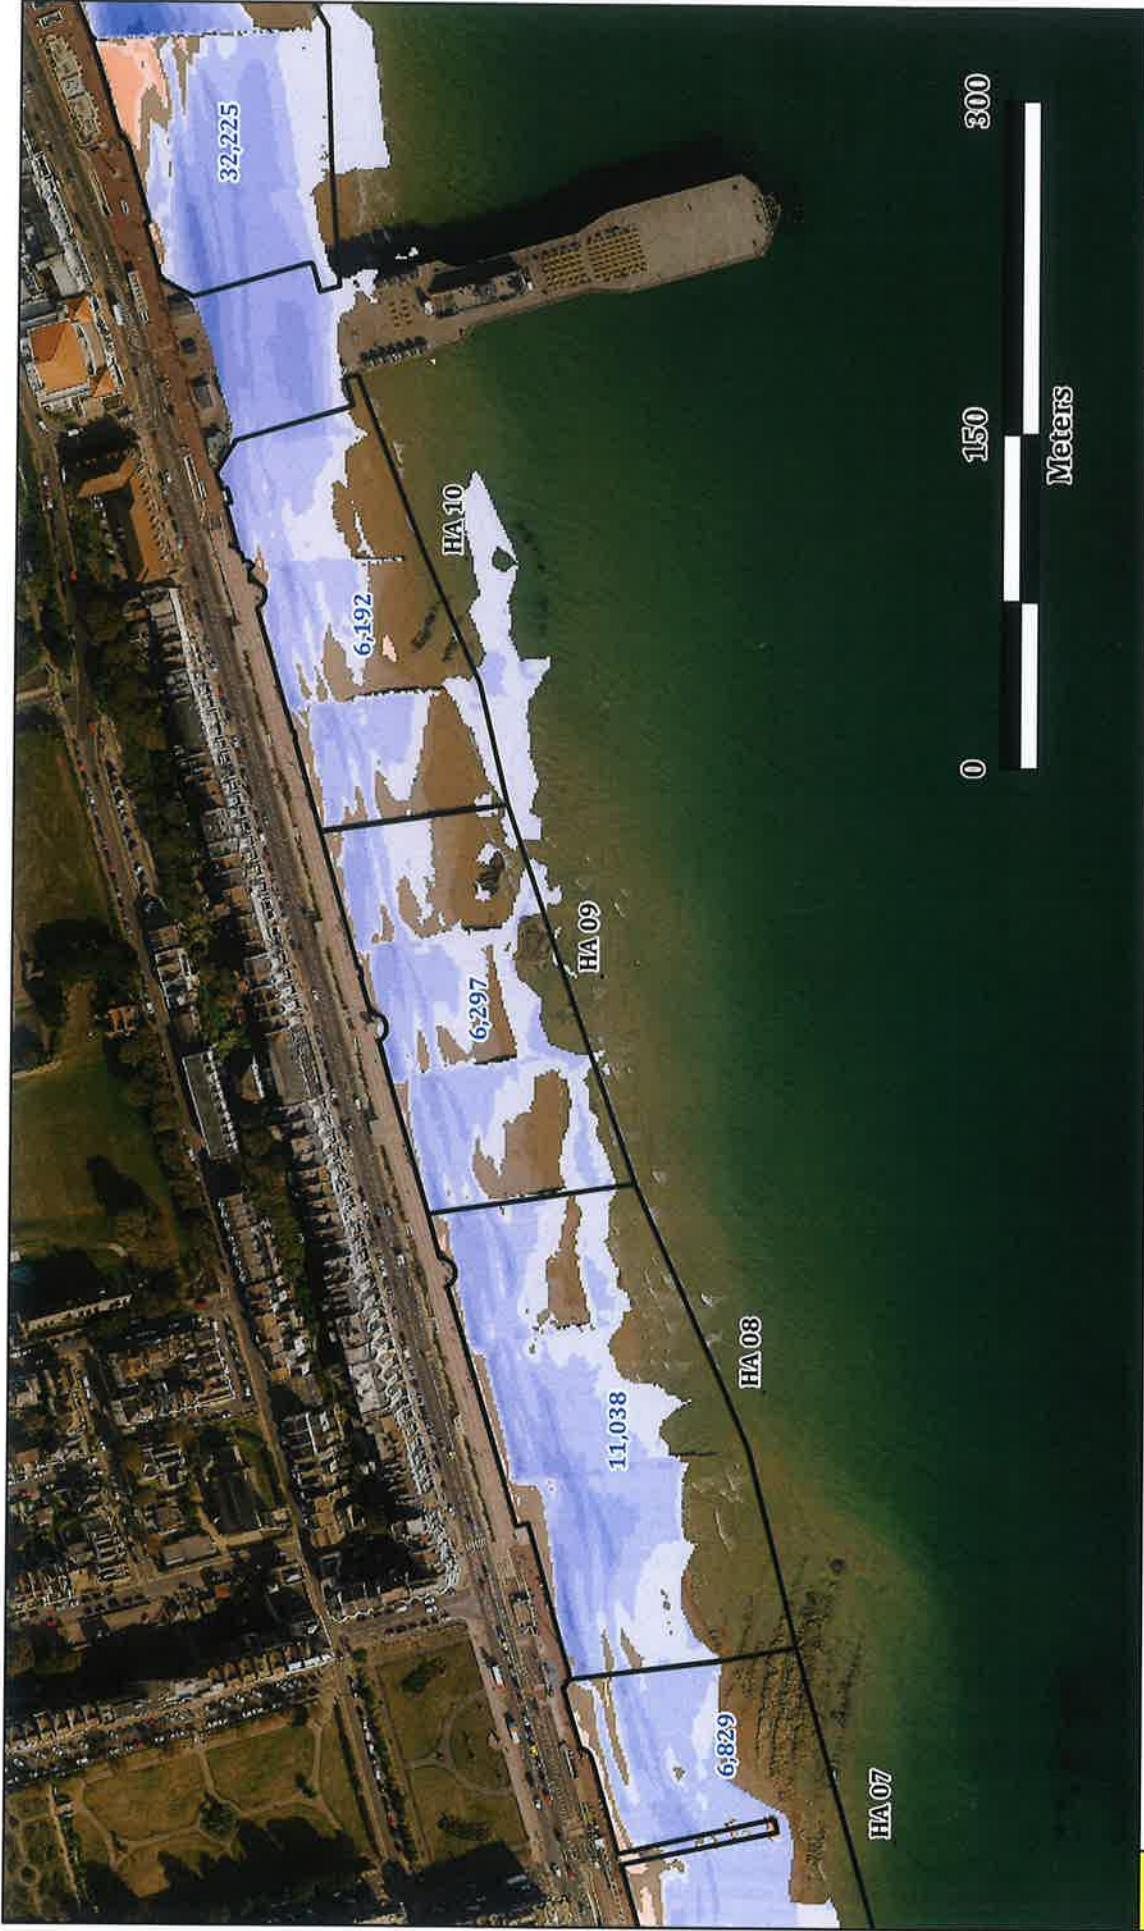
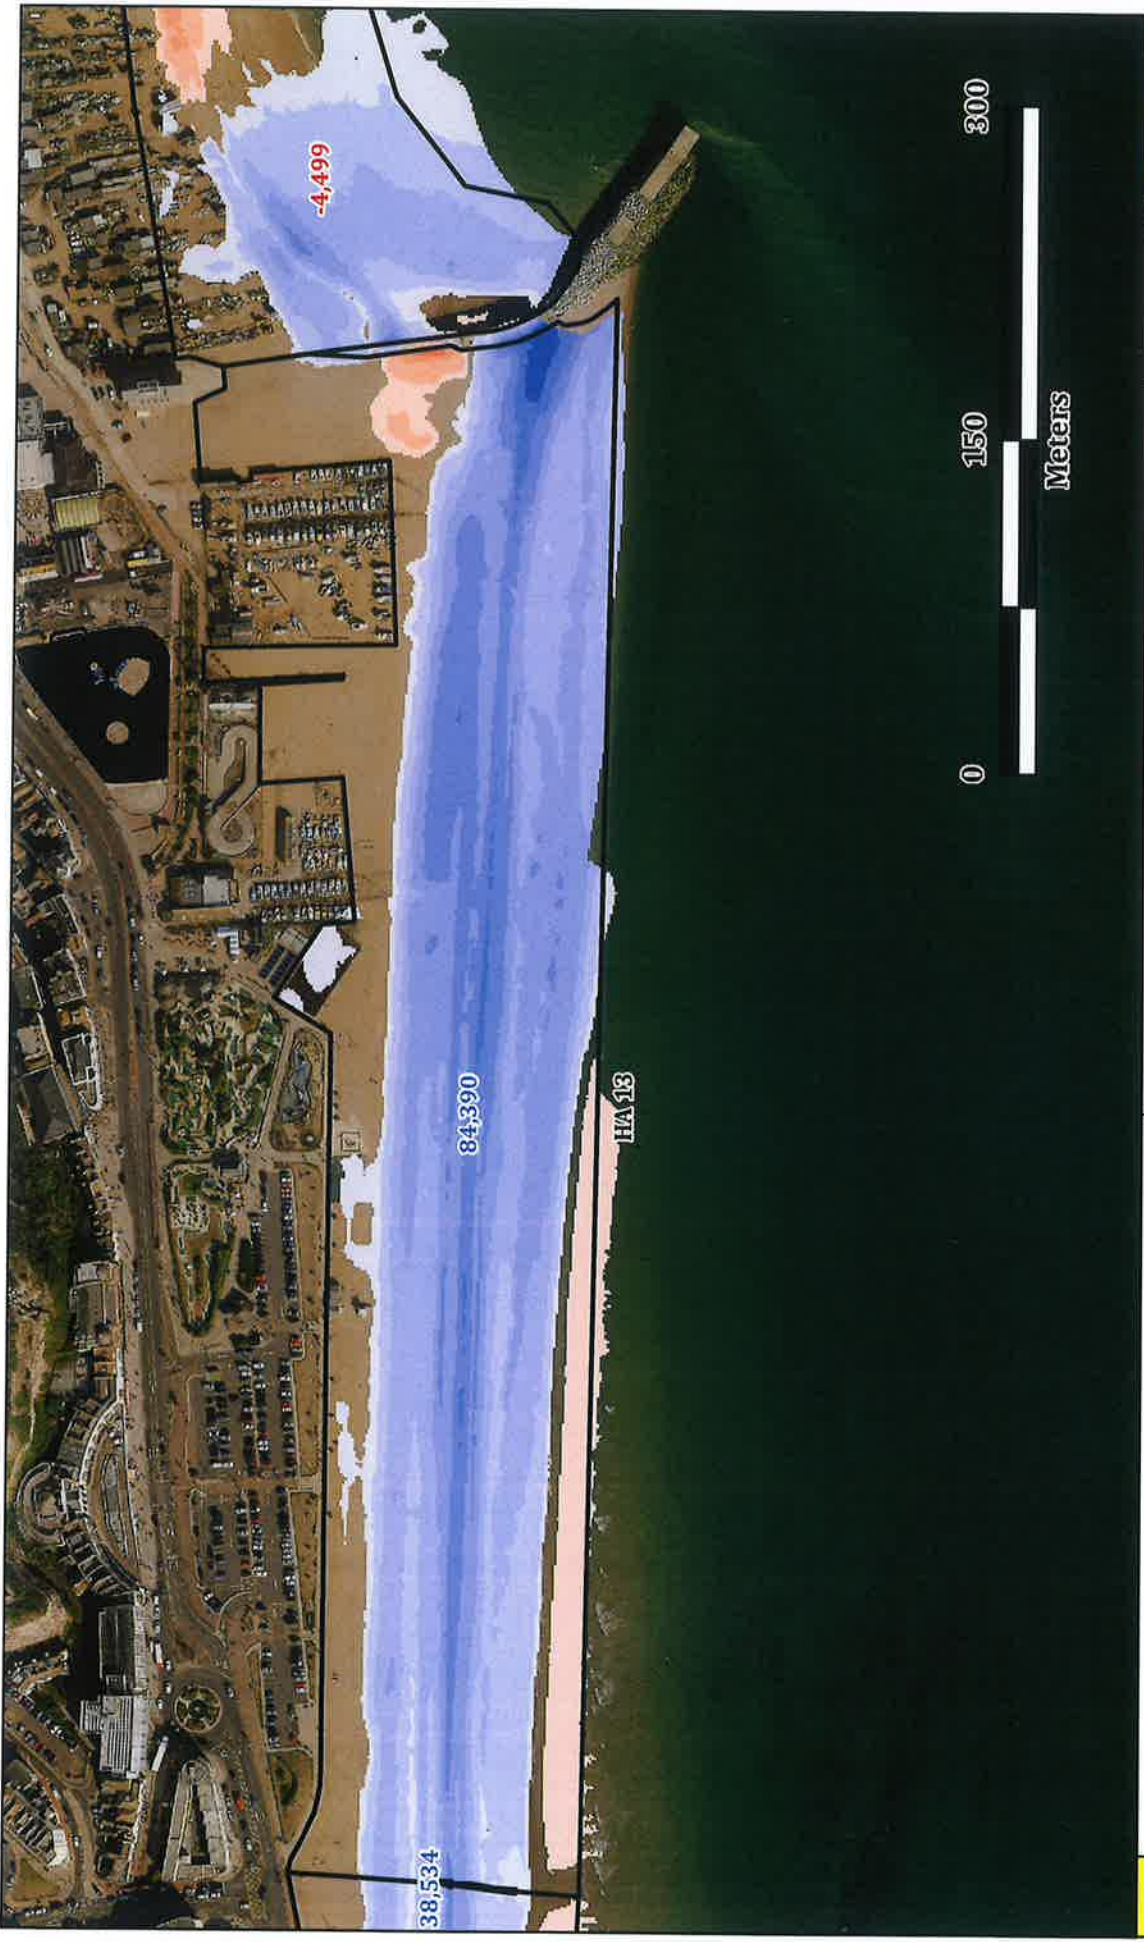
South East Regional Coastal Monitoring Programme  
Difference Model 2004 - 2021

| Survey type | Survey dates | Comments |
|---|---|---|
| Baseline to Spring | | <p>30/09/2004<br/>13/04/2021</p> <p>Since monitoring started in 2004 Hastings has gained 222,642m<sup>3</sup>. The majority of this can be attributed to sediment transported from Pevensy Bay.</p> <p>With the exception of one polygon between western boundary and the large rock groyne to the west of Fisherman's beach, the entire frontage gained material. The Fisherman's beach and Rock-a-Nore both lost 4,499m<sup>3</sup> and 5,584m<sup>3</sup> respectively.</p> |

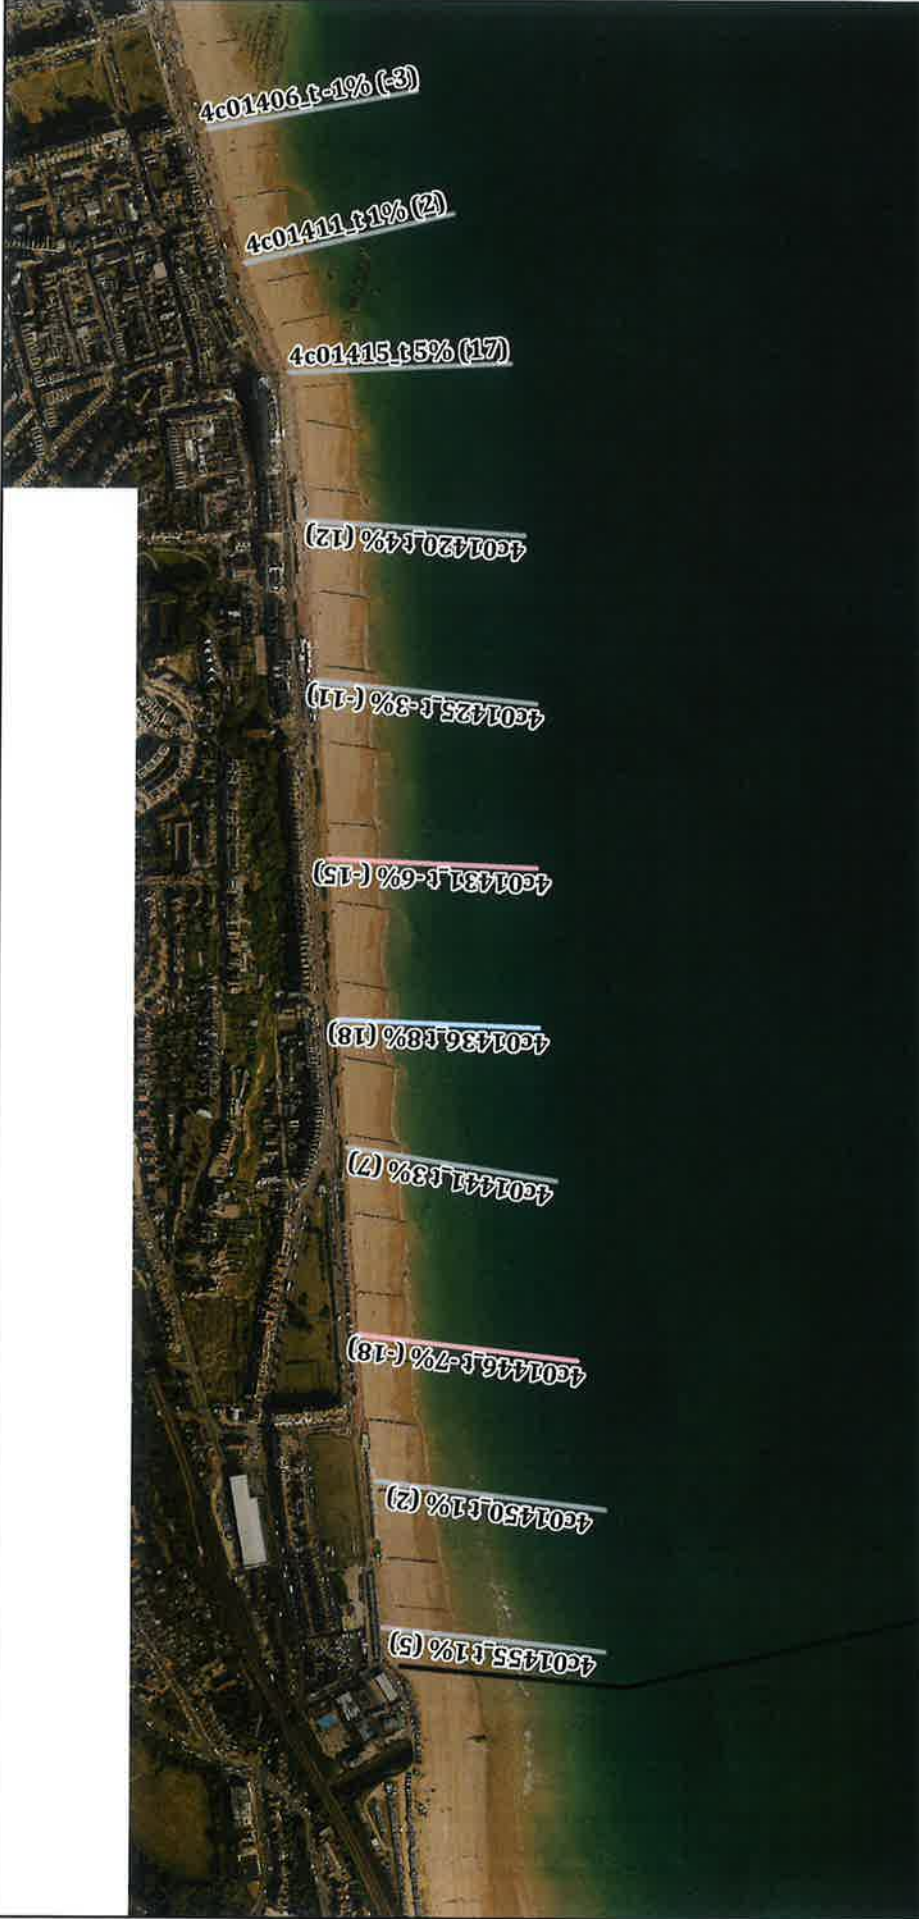
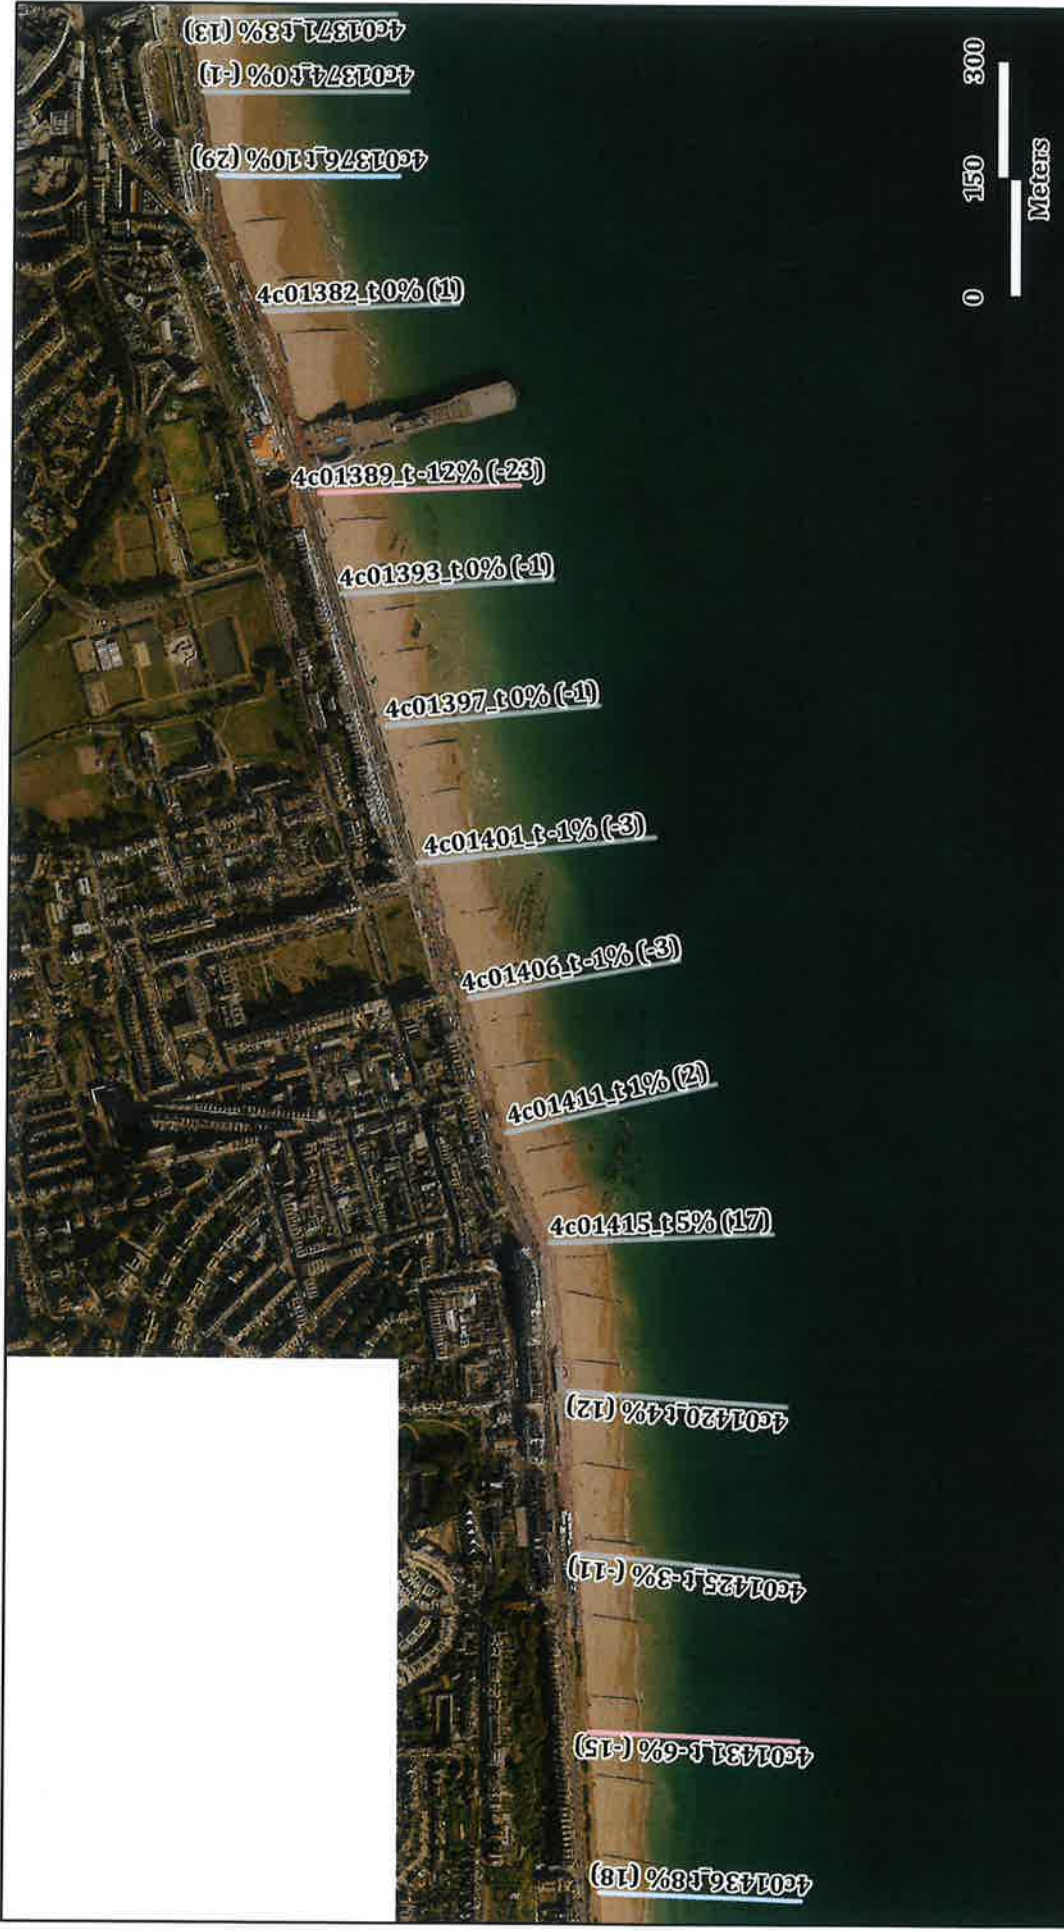
### Profile Change Summary for Spring 2021 to Autumn 2021

| Survey type | Survey dates | Comments |
|---|---|---|
| Spring to Autumn | Profile Change Summary | <p>13/04/2021<br/>11/10/2021</p> <p>In the short term, April to October, the beach levels appear stable. Profile 4c01389, directly west of the Pier lost 23m<sup>2</sup> (12%) which was the largest recorded loss of the frontage. Profile 4c01376, east of the Pier, recorded the largest gain of 29m<sup>2</sup> (10%), with Profile 4c01353 gaining 25m<sup>2</sup> (4%).</p> |

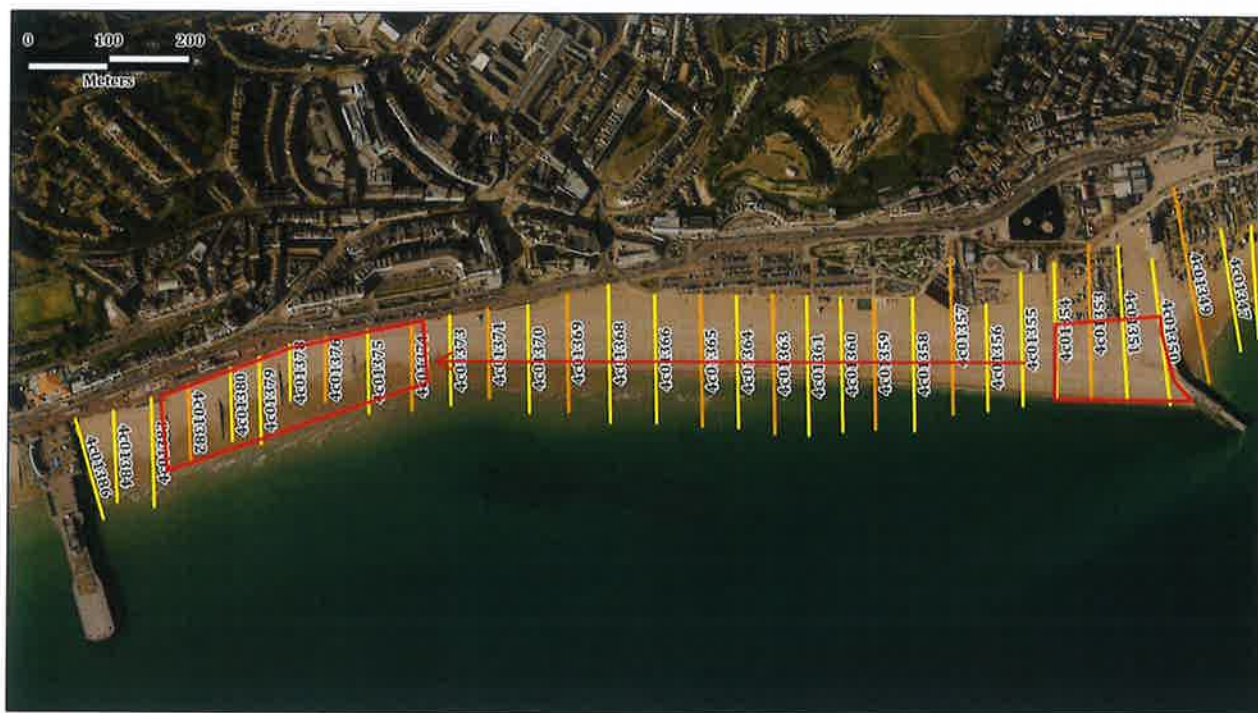
| Description of Works/Notes |
|---|
| 8,827 tonnes of shingle to the west of the Harbour Arm was extracted and deposited in the four groyne bays to the east of Hastings Pier. |

| Description of Frontage | | | |
|---|---|---|---|
| Before | Build-up of beach material on the western side of the Harbour Arm. | After | Beach levels reduced. |

| Quantify extraction/deposition (Note: if volume unknown conversion used is 1.8 tonne: 1 m <sup>3</sup> of material) | | | | | | |
|---|---|---|---|---|---|---|
| 4c01350 | 4c01354 | 4,904 | | | | Shingle |
