**Hastings Borough Council  
Ecclesbourne Glen – Landslides - 2014**

Job title: Ecclesbourne Glen - landslides Job number 02255AA

Document title Desk Study and Inspection Report File reference

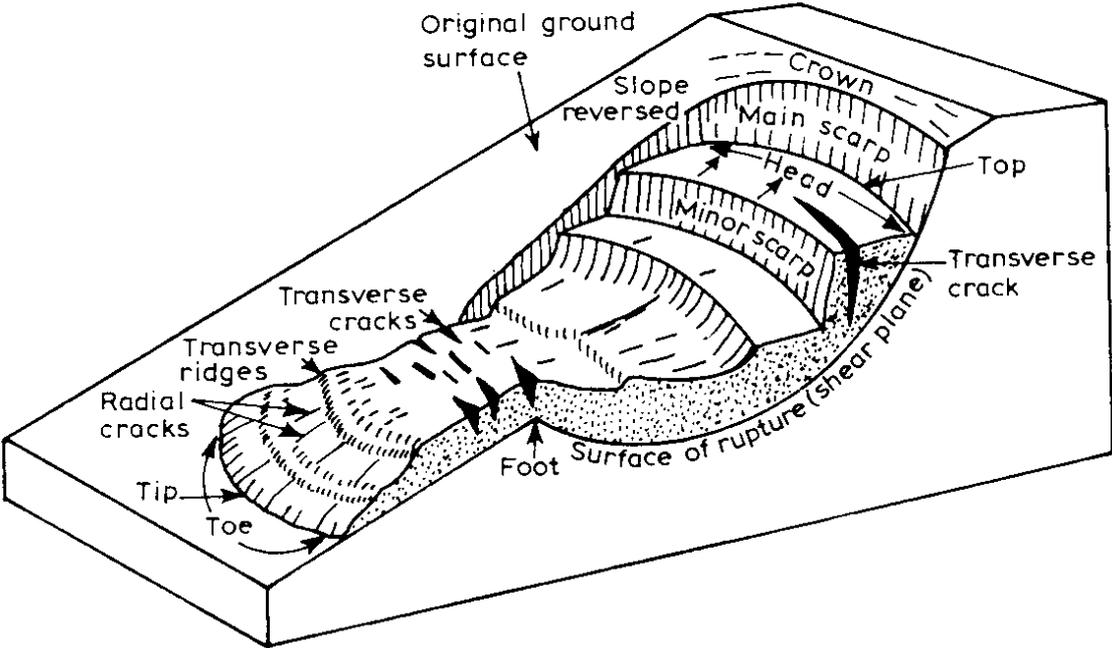
Pictorial illustration of landslide morphology and main features/descriptors

In terms of landslide description and features, reference has been made to the nomenclature and terms presented in the paper by Cruden and Varnes (Ref. 9). To assist further, a glossary of terms and a pictorial illustration of landslide morphology and features are presented in Section 10. Figure 003 depicts the features identified at the site. It should be noted that observation points were located using a hand-held GPS; these are reported to be accurate within +/- 2-3m, and hence Figure 003 represents an engineering geology sketch map.

In this report the use of the word 'Landslide' covers both existing known landslides and those which a practitioner might also reasonably predict based on geology, geomorphology, and terrain geometry. The terminology of landslides used in this report is based upon Cruden and Varnes (1996) – Ref. 9).
